Manhole Inspection Summary

Manhole # S47II_016MH

Insp Date: **5/1/08 11:05 AM**

Location Address: **Montford Ave**

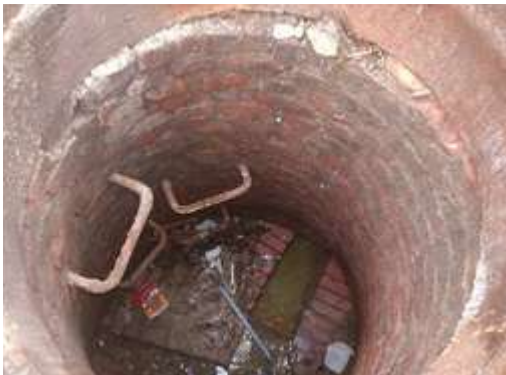
Defect 2

Condition: ☐ Sound ☐ Cracked ☐ Root Intrusion ☒ **Loose Brick** ☐ Deteriorated

Deterioration

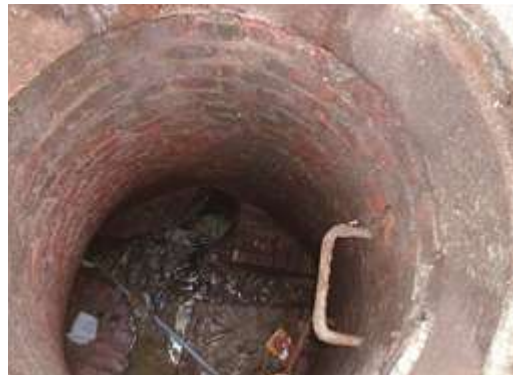
Defect 1

Infiltration: ☐ None ☒ **Joint** ☐ Cracks ☒ **Mortar** ☐ Roots ☐ Wall

Infiltration

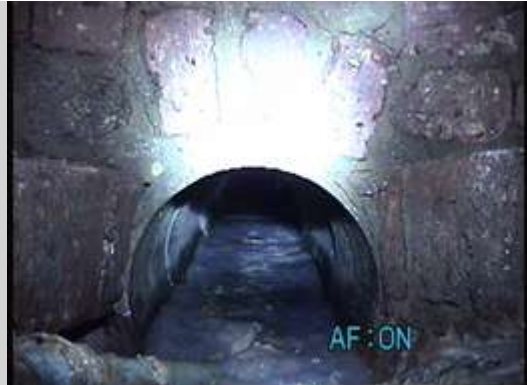
12 O'Clock Outflow

8 in. Circular Gravity Sewer
Pipe Out @ 12 O'Clock

Pipe Height: **8.4** (in.) Rod and Bar (Angled)
Pipe Material: **Clay** ☐ Pipe Lined
Invert Depth: **9.00** (ft.) Flow Characteristics: **Slow**
Deposits: ☒ None ☐ Mud ☐ Sludge ☐ Debris ☐ Grease
Silt Depth: (in.) Deposits Extent:
Infiltration: **None** Pipe Seal Cond: **Sound**

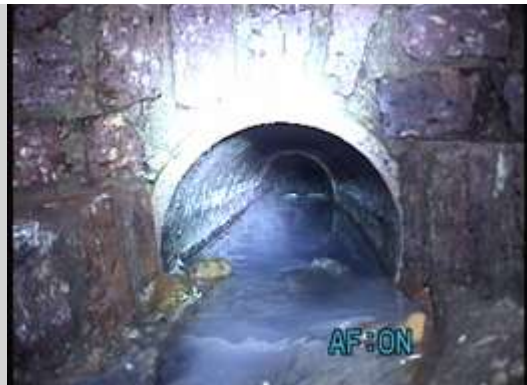
3 O'Clock Inflow

8 in. Circular Gravity Sewer
Pipe In @ 3 O'Clock

Pipe Height: **8.4** (in.) Rod and Bar (Angled)
Pipe Material: **Clay** ☐ Pipe Lined
Invert Depth: **8.50** (ft.) Flow Characteristics: **Slow**
Deposits: ☒ None ☐ Mud ☐ Sludge ☐ Debris ☐ Grease
Silt Depth: (in.) Deposits Extent:
Infiltration: **None** Pipe Seal Cond: **Sound**

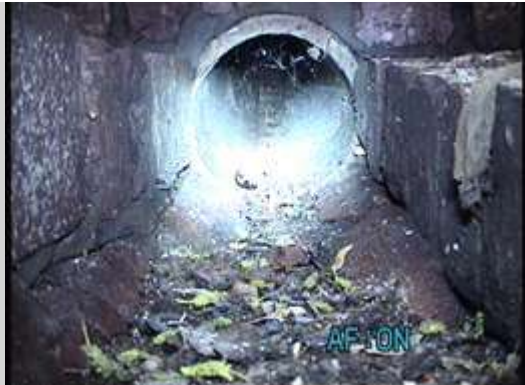
6 O'Clock Inflow

6 in. Circular Gravity Sewer

Pipe In @ 6 O'Clock

Infiltration: **None**

Pipe Seal Cond: **Sound**

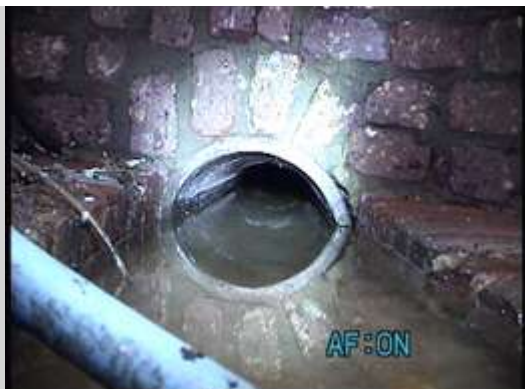
9 O'Clock Inflow

8 in. Circular Gravity Sewer

Pipe In @ 9 O'Clock

Infiltration: **None**

Pipe Seal Cond: **Sound**
